Installation Effects on Heat Transfer Measurements for a Turbine Vane

Marc D. Polanka and Matthew Meiningen
 Air Force Research Laboratory AFRL/PRTT
 1950 Fifth Street
 WPAFB, Ohio 45459

Experiments have been conducted for a modern high pressure turbine vane in the USAF Turbine Research Facility (TRF). This turbine vane was instrumented with two types of heat flux gauges. The first was a thin film Upilex gauge design wrapped over the full airfoil surface, while the second consisted of Pyrex insert type gauges. Initial measurements showed significant discrepancies in the resultant Nusselt number from these two types of gauges. As the inlet Reynolds number was decreased, these discrepancies collapsed to single laminar level Nusselt number. This suggested a potential change in the flowfield for one of the gauge types. Interrogation of the vane surface metrology showed depressions in the epoxy filler between the Pyrex insert and the metal airfoil. After filling these depressions, the vane was reinstalled and identical tests repeated. This second test revealed a better comparison for two of the Pyrex insert gauges while minimal change resulted in two other gauges. Similar results were

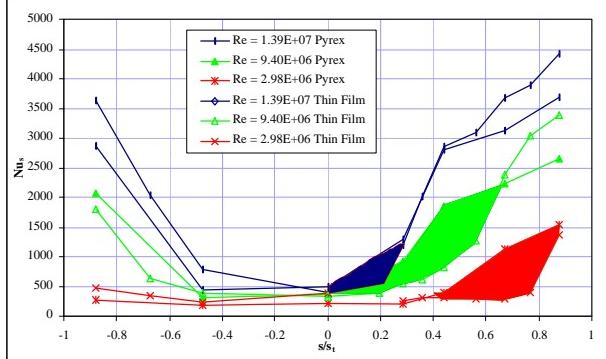
Figure 8 Transitional Region of SS Heat Transfer

The Pyrex gauges typically have a faster increase in Nusselt number, suggesting that transition occurs sooner than is measured with the thin film gauges. Figure 8 highlights this early transition by comparing the data for only three of the runs on the suction side. It is apparent in this figure that the Pyrex gauges have transitioned earlier than the thin film gauges (the cross hatched region). To understand the transitional nature of the suction side flow, the data was compared to laminar and turbulent flat plate correlations as given:

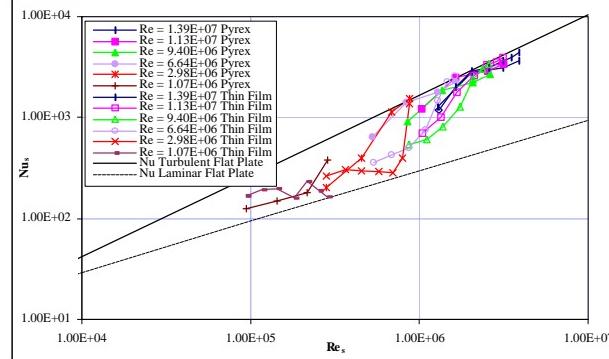
Figure 9 Local Nu vs. Local Re Comparison

Plotting the Nusselt number data versus the Reynolds number as in Figure 9 suggests that the Pyrex gauges may actually skip transition completely and become fully turbulent. A possible explanation for this result is that the boundary layer was locally tripped at the Pyrex to metal interface resulting in a turbulent boundary layer for Pyrex gauges.

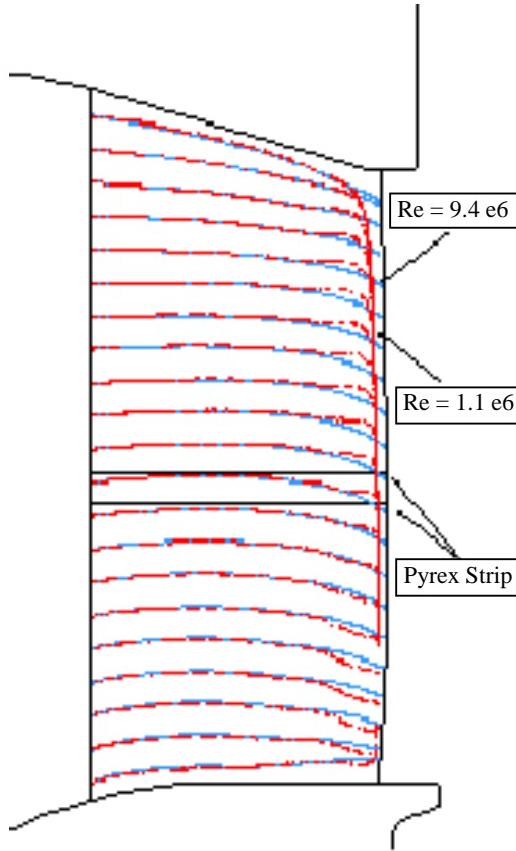
Figure 10 Streaklines over Pyrex Strip

When instrumenting these vanes, the metal was machined away and a piece of Pyrex was shaped to fit the contour of the airfoil. This piece was epoxied in place. The epoxy filled under the Pyrex and in-between the Pyrex and the airfoil. Afterwards the metal was polished to smooth out the interface with the epoxy. Extensive surface metrology measurements were taken of the interface between the Pyrex insert and the metal airfoil. These were acquired with the Cyber Optics Cyberscan Cobra laser metrology system. The head has a 17 mm focal length with a 0.5 mm depth measuring range with a resolution of 0.125 μm . Figure 11a shows a typical trace across the Pyrex insert from one side of the metal to the other. As is shown, a significant trench occurred within the epoxy layer. It is presumed that the epoxy layer sunk, probably during curing. This was probably due to the width of the channel that was machined out for the insert. This channel was about 4.25 mm with the insert width being 2.75 mm. This extra 1.5 mm is about two times wider on the current vane than on other similar installations. Therefore, more epoxy was needed to fill the gap which shrunk upon hardening. Also apparent in the figure is that the actual gauge is lower than the metal surface. This is believed to be due to the same shrinking phenomena. As the epoxy cured, the Pyrex submerged into the cavity.

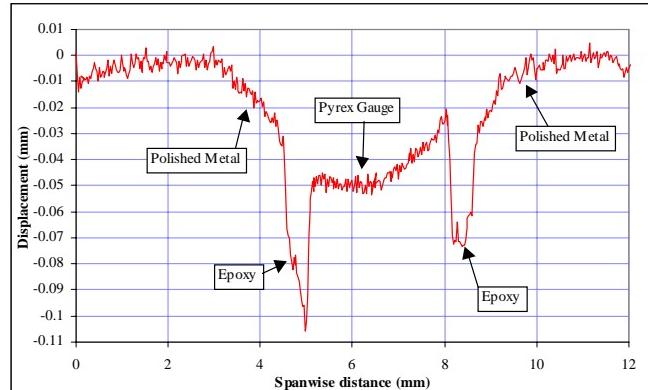
Figure 11a Typical Surface Trace Across Pyrex Insert

What is important is that a surface discontinuity occurred at the interface. The polishing of the metal surface resulted in a tapering of the surface down to reach the Pyrex insert. At the interface, the epoxy layer was significantly lower than the metal surface. This depression was anywhere from 0.05 to 0.12 mm. After the epoxy layer, the Pyrex gauge itself was typically below the metal surface. The Pyrex ranged from 0.02 to 0.05 mm below the metal surface on the opposite side of the epoxy. Again that portion of the metal was already 0.02 mm or so below the rest of the metal along the span due to the polishing. On the far side of the gauge, the same phenomena occurred with the trenched epoxy rising back up to the polished metal. Comparing these depressions with the nominal 0.05 mm boundary layer thickness for the higher Reynolds number shows significant penetration of the boundary layer. This could result in a localized tripping of the boundary layer to turbulent values at the interface as described by Liess (1975). In fact the epoxy gap is actually deeper than the boundary layer thickness. This coupled with the streakline pattern could actually cause the boundary layer to separate at the epoxy interface. As the Reynolds number is decreased, the boundary layer thickness increased, which would result in less of an impact on the boundary layer and any type of separation effect. Therefore the data for the two types of gauges could be expected to collapse.

While this epoxy interface certainly does not constitute a uniform surface roughness it does represent an obstacle to the main flow field. This interface can not be directly correlated to a standard trip wire either as the actual magnitude of the trip is questionable. For instance should the trip be quantified based on the total gap (about 0.1 mm) or based on the distance below the Pyrex surface (about 0.05 mm)? Also what is the contribution of the 0.05 mm depression of the entire Pyrex strip? Regardless of the appropriate value for k , the critical k values can be calculated. From equation 1 above k_{crit} equals approximately 0.040 mm for the majority of the suction surface of the airfoil. Again this represents the roughness height that will cause transition. The fully effective trip height calculated from equation 2 is about 0.048 mm assuming a low M# flow. Over most of the suction surface the Mach number is close to 1.0 which would result in a slightly higher value of 0.066 mm. These values are certainly of the same

order as the surface discontinuities measured at the Pyrex to metal interface. Lastly, comparing these k values with the displacement height given above yields ratios well beyond the $k/\delta^* = 0.3$ which results in the trip occurring right at the interface. While it may not be possible to predict the exact nature of the flow over the epoxy interface, it is reasonable to expect that the flow has been altered from its laminar state and would exhibit more of a turbulent nature. This would correlate directly to higher heat transfer rate more closely resembling fully turbulent behavior.

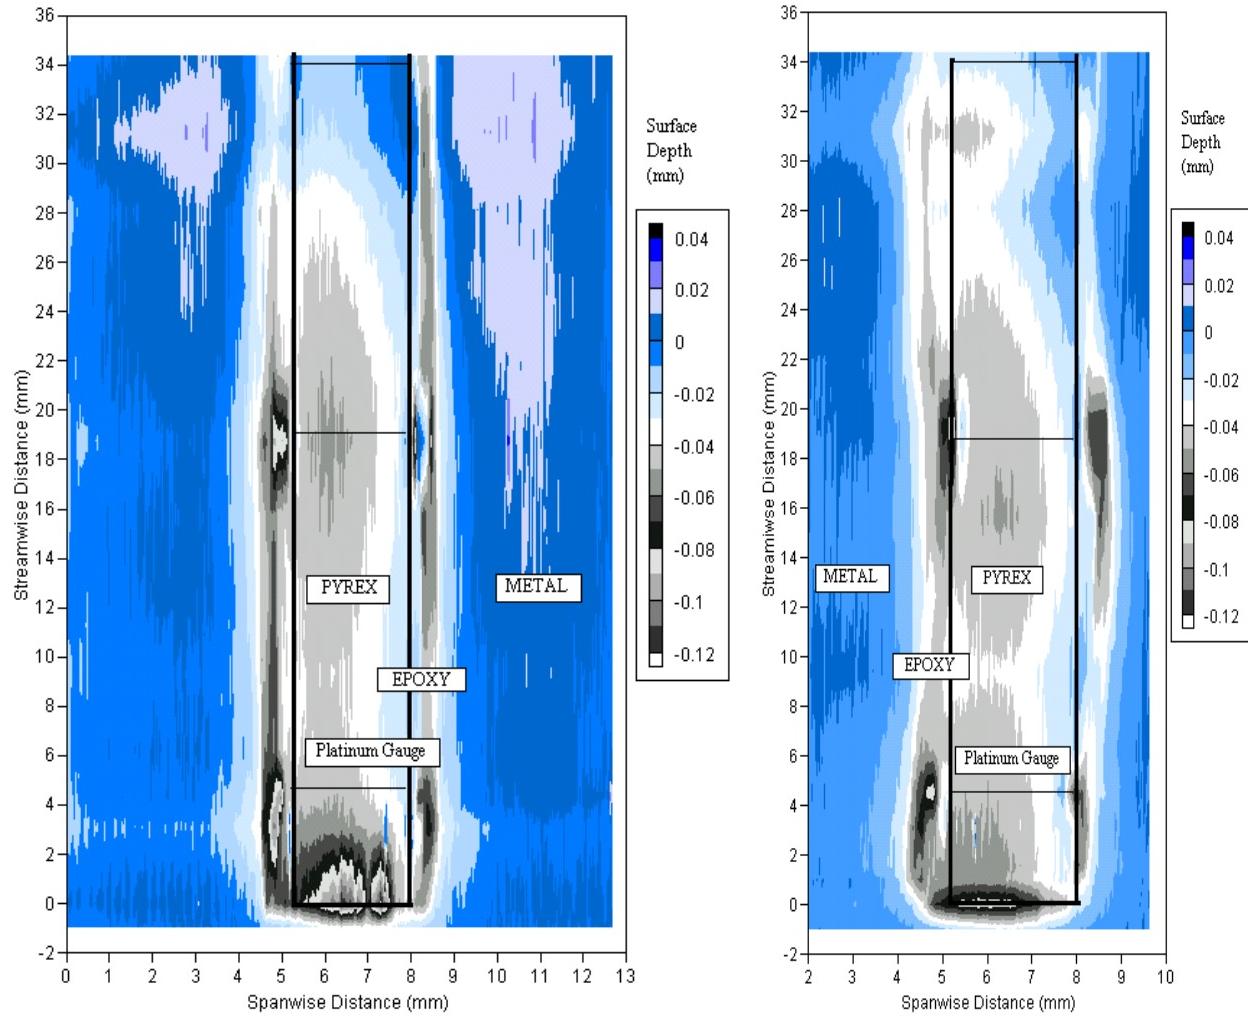
Figure 12 Suction Side Surface Contours a) Initially and b) After Filling Epoxy Gap

Figure 12a shows the measurable portion of the suction surface of the vane. This figure has a reference point of zero at the trailing edge of Pyrex insert. The last three suction side gauges are also shown for reference. The surface contours depict the depth of the surface below the metal (set equal to zero). This figure highlights the depression of the Pyrex into the metal and furthermore accents the trench that occurred all along the epoxy interface both on the sides as well as at the trailing edge. While no measurements were taken at the leading edge of the Pyrex strip it is assumed that a similar trench would have occurred there as well.

With this knowledge and the Cyber Optics measurements of the airfoil surface, an attempt was made to smooth out the epoxy interface. Thin layers of paint (DH 1606 High Heat Ceramic Based Paint from Dupli-Color Products) were applied on the sides of the epoxy trough to allow the paint to flow into the deepest portion of the trough. Measurements were taken after a couple of paint layers were applied. These measurements showed that the paint created a smooth transition between the metal and the Pyrex in some regions and that more paint was needed in others. After about four paint layers on both the pressure side and suction side, full surface measurements were acquired. As shown in Figure 11b and 12b, the paint filled the gap between the metal and the Pyrex. Also prevalent in these figures is that no work was performed on the Pyrex gauge itself. It is still submerged below the metal surface. A further note is that it was difficult to measure the region near the front of the suction side Pyrex strip. As shown in Figure 12, measurements were only taken from the second suction side gauge on back. No measurements were acquired at the leading edge portion of this strip. It was also difficult to apply the paint into this region

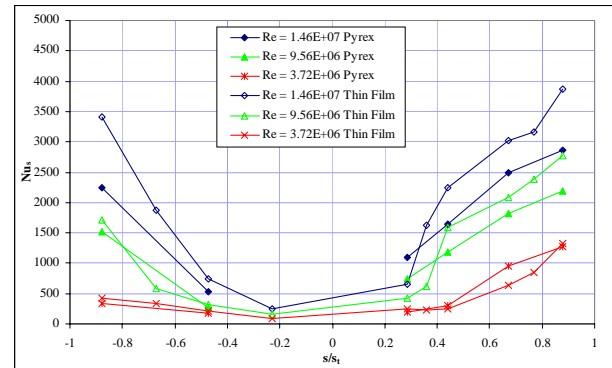
Figure 14 Decrease in Transition in Pyrex Gauges

Looking just at the same three Reynolds numbers as in Figure 8 shows an overall improvement in the comparison of the two types of gauge technologies (Figure 14). In fact the last two Pyrex gauges follow their thin film counterpart significantly better than the original runs. However the first two Pyrex gauges still show signs of early transition. This is shown more clearly in Figure 15 where only the second and third Pyrex gauges are shown with their thin film counterparts. This figure compares the local Nusselt number with the local Reynolds number for only these gauges. As shown, there is still a discrepancy between the Pyrex and thin film gauges at the more upstream location while the downstream location shows a much better comparison. This is also seen in comparing the local Reynolds number to the Nusselt number (Figure 16) for each test run. This suggests that there still is a problem locally on the airfoil surface. This could be attributable to not filling enough along the side of the Pyrex strip in the upstream region or an influence from the beginning surface of the strip. As mentioned previously this was a difficult region to gain access from both a surface metrology and a filling standpoint. Therefore, not much surface adjustment was made in this region. This could still be the reason for the local discrepancies.
